# Microcontroller Technical Information

PG-FP4 Flash Memory Programmer  Usage Restrictions		Document No.	ZBG-CD-07-0029	1/2
		Date issued	May 21, 2007	
		Issued by	Development Tool Solution Group Multipurpose Microcomputer Systems Division Microcomputer Operations Unit NEC Electronics Corporation	
Related documents	PG-FP4 User's Manual: U15260EJ4V0	Notification classification	√	Usage restriction
				Upgrade
				Document modification
				Other notification

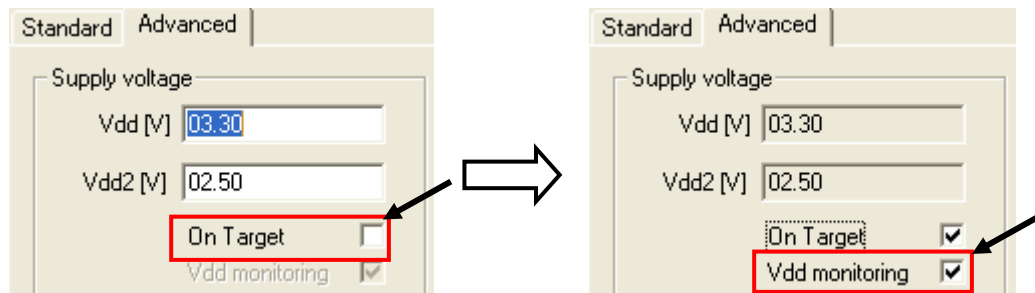
A function for selecting enable or disable of the power supply detection function at the VDD pin, with the setting that VDD is supplied from the target system, has been added. This function has been added to the Advanced Setup menu that is selectable from [Setup...] under the [Device] menu. Select the “Vdd monitoring” check box to enable this function. Clear the “Vdd monitoring” check box to disable this function. The “Vdd monitoring” check box becomes selectable by selecting the “On Target” check box as shown below.

**Caution** When this function is disabled, the product can be used even if the VDD pin of the target system and that of the PG-FP4 are not connected, as long as the VDD generated in the target system and the VDD of the output signal generated by the PG-FP4 match.

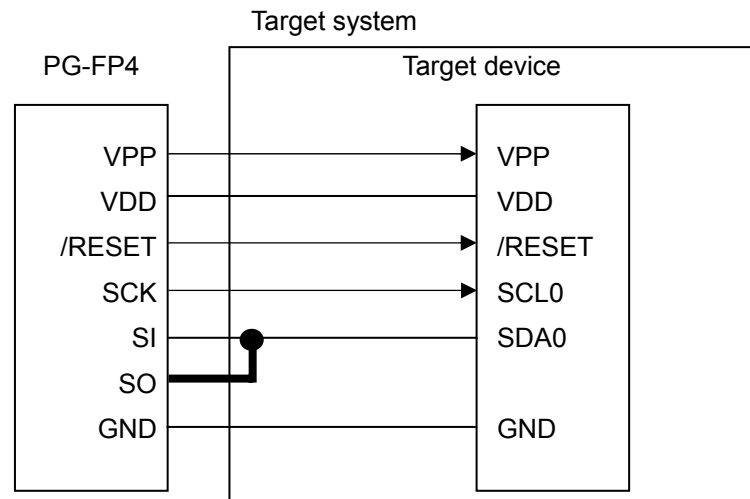
**Figure 2-6. Connection Diagram**

When I<sup>2</sup>C communication mode is used and the IIC/78K0S/KX1+ adapter is not used, short the SI pin and SO pin in the target system.

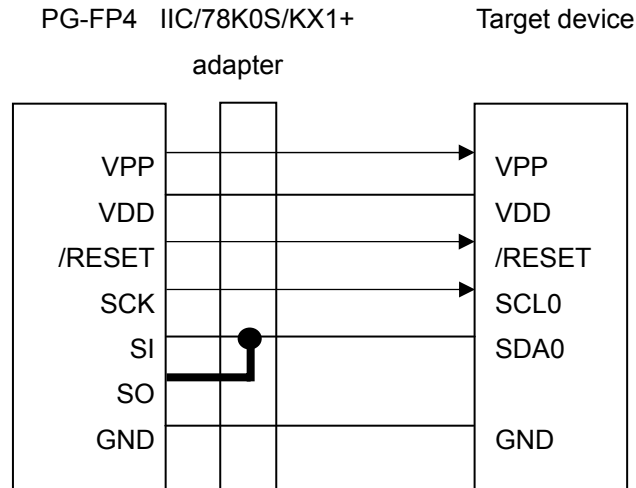
**Figure 2-7. Connection Diagram When Using IIC/78K0S/KX1+ Adapter**

When I<sup>2</sup>C communication mode is used and the IIC/78K0S/KX1+ adapter is used, shorting the SI pin and SO pin in the target system is not required.

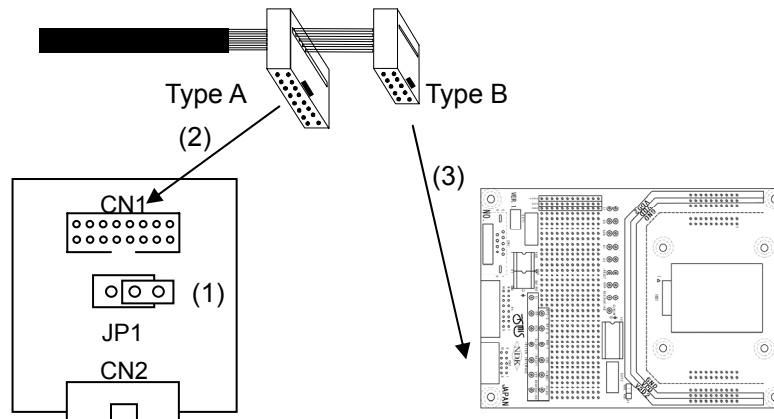
**Figure 2-8. Connection Diagram When Using IIC/78K0S/KX1+ Adapter**

<Usage when writing to two-power-supply flash memory microcontroller>

- (1) Leave JP1 open.
- (2) Connect the program adapter and target connector type B (10 pins) of the target cable.
- (3) Connect target connector type A (16 pins) of the target cable and the IIC/78K0S/KX1+ adapter (CN1).

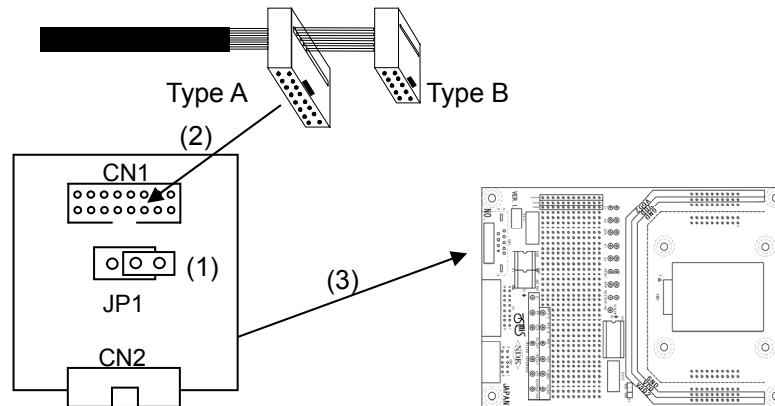
**Figure 2-9. Connection Diagram When Using IIC/78K0S/KX1+ Adapter**

<Usage when writing to single-power-supply flash memory microcontroller>

- (1) Leave JP1 open.
- (2) Connect target connector type A (16 pins) of the target cable and the IIC/78K0S/KX1+ adapter (CN1).
- (3) Connect the program adapter and the IIC/78K0S/KX1+ adapter (CN2).

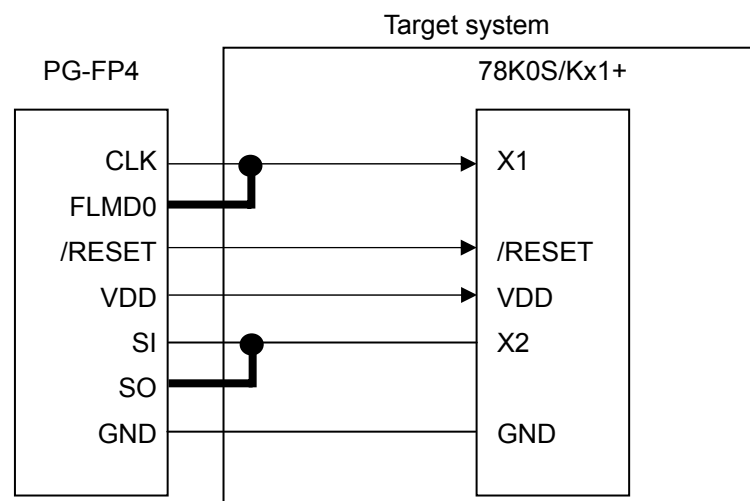
**Figure 2-10. Connection Diagram**

When the 78K0S/KX1+ is used and the IIC/78K0S/KX1+ adapter is not used, short the SI pin and SO pin, as well as the CLK pin and FLMD0 pin in the target system.

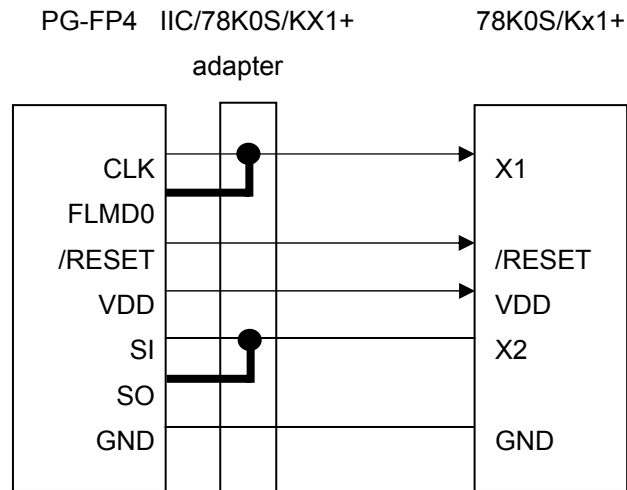
**Figure 2-11. Connection Diagram When Using IIC/78K0S/KX1+ Adapter**

When the 78K0S/Kx1+ is used and the IIC/78K0S/KX1+ adapter is used, shorting the SI pin and SO pin, as well as CLK pin and FLMD0 pin in the target system is not required.

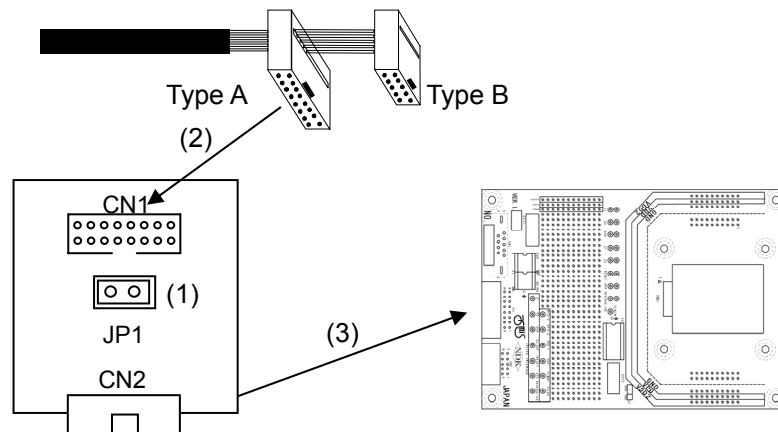
**Figure 2-12. Connection Diagram When Using IIC/78K0S/KX1+ Adapter**

<Usage when writing to 78K0S/Kx1+>

- (1) Short JP1.
- (2) Connect the target connector type A (16 pins) of the target cable and IIC/78K0S/KX1+ adapter (CN1).
- (3) Connect the FA adapter with the IIC/78K0S/KX1+ adapter (CN2).

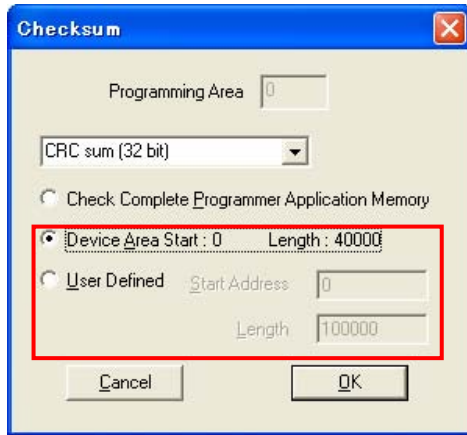
<When a parameter file that does not support the data flash area is downloaded>

When [Checksum] in the [File] menu is executed, the window display varies depending on whether or not the downloaded parameter file supports the data flash area.

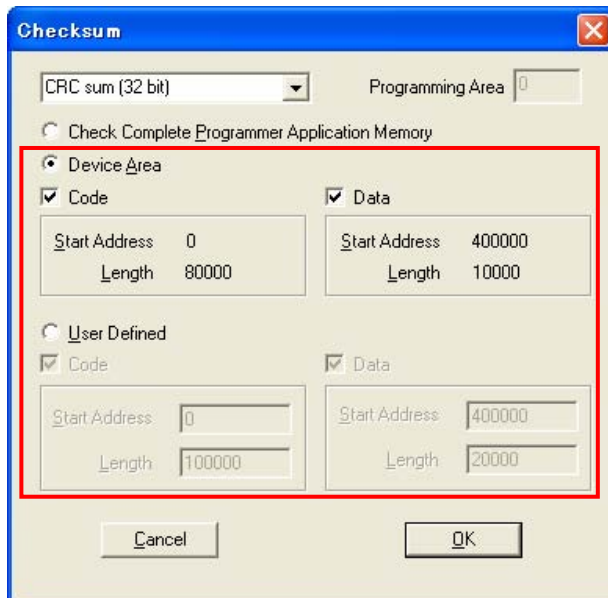
<When a parameter file that supports the data flash area is downloaded>

After clicking the OK button, the following information will be displayed in the File Checksum area of the programmer parameter window.

File Checksum	
Type:	CRC sum (32 bit)
Code flash:	A5F81C7E (000000-07FFFF)
Data flash:	8D812A84 (400000-40FFFF)
Total:	F4D11DAE

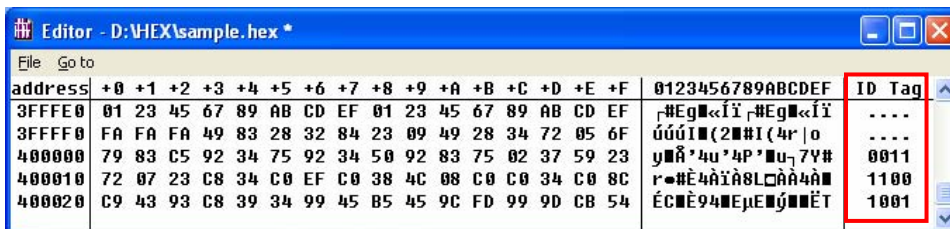
An ID Tag row has been added to the [HEX Editor] in the [File] menu. The ID Tag row is used in microcontrollers that support the data flash area. Only the values at addresses 400000h and beyond can be edited in the ID Tag row.

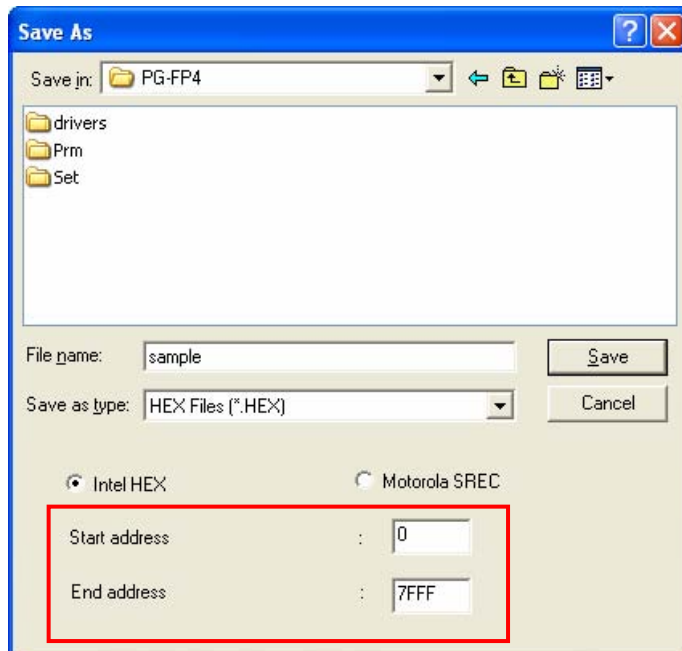
<When a parameter file that does not support the data flash area is downloaded>

When a parameter file is downloaded using the [HEX Editor] and the file is saved as, the available options in the [Save As] window vary depending on whether or not the downloaded file supports the data flash area.

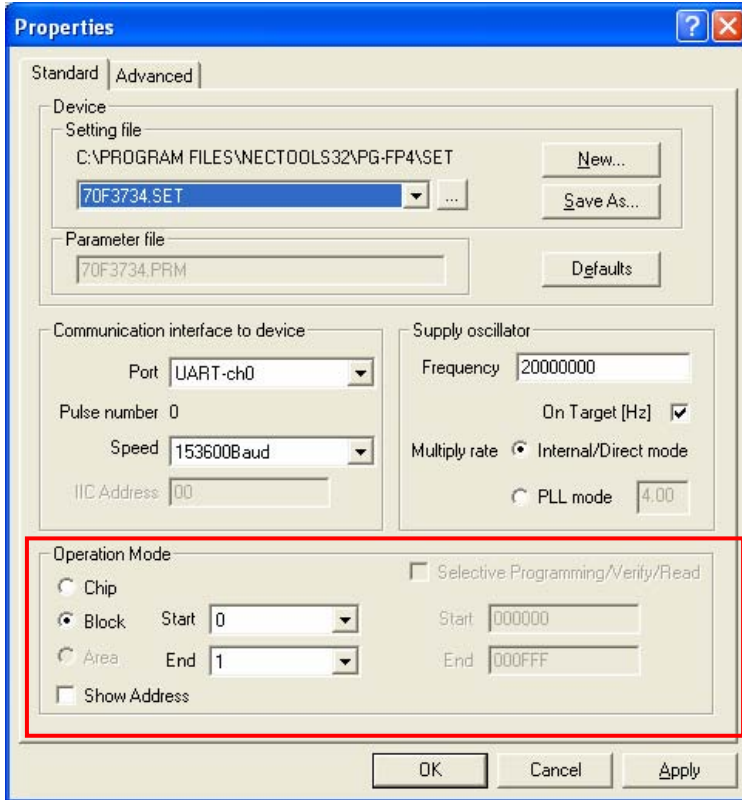
<When a parameter file that does not support the data flash area is downloaded>

The available options on the Standard tab in the Device Setup window vary depending on whether or not the downloaded file supports the data flash area.

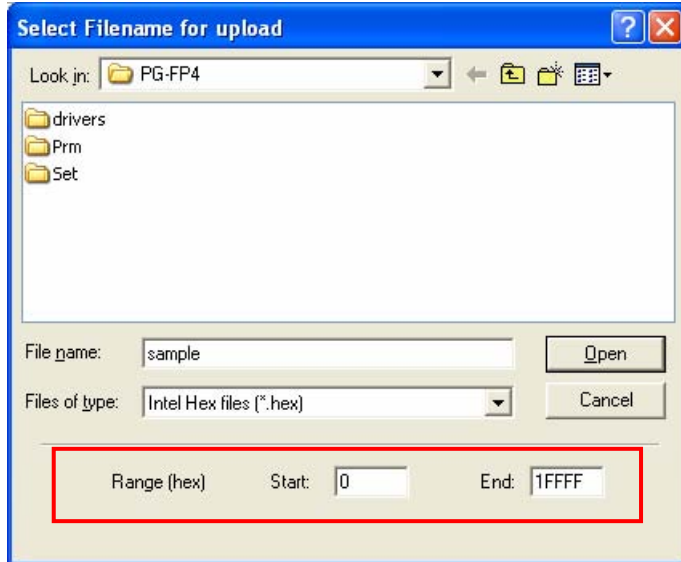
<When a parameter file that does not support the data flash area is downloaded>

The available options in the “Select Filename for upload” window vary depending on whether or not the downloaded file supports the data flash area.

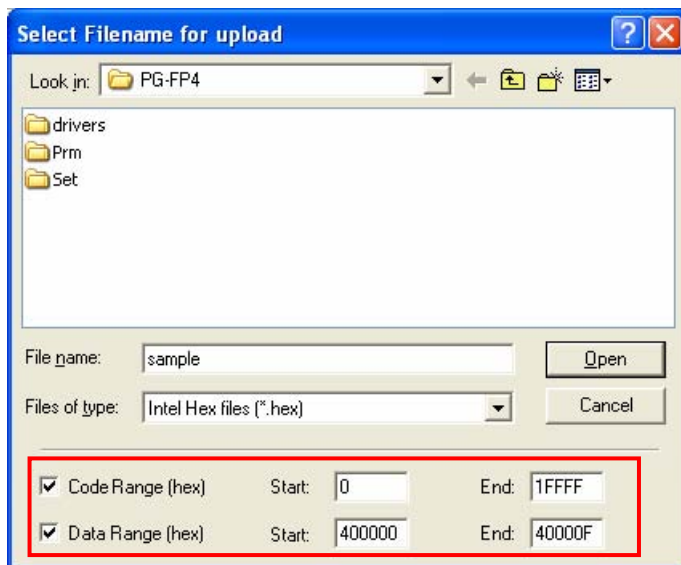
<When a parameter file that supports the data flash area is downloaded>

**Caution** Specify twice the required for the data range in order to accommodate the ID tag data.

Example: When uploading 16 bytes of data flash data from address 400000, specify 32 bytes.
