SLG46826-EV Errata Note

This document contains the known errata for SLG46826-EV and the recommended workarounds.

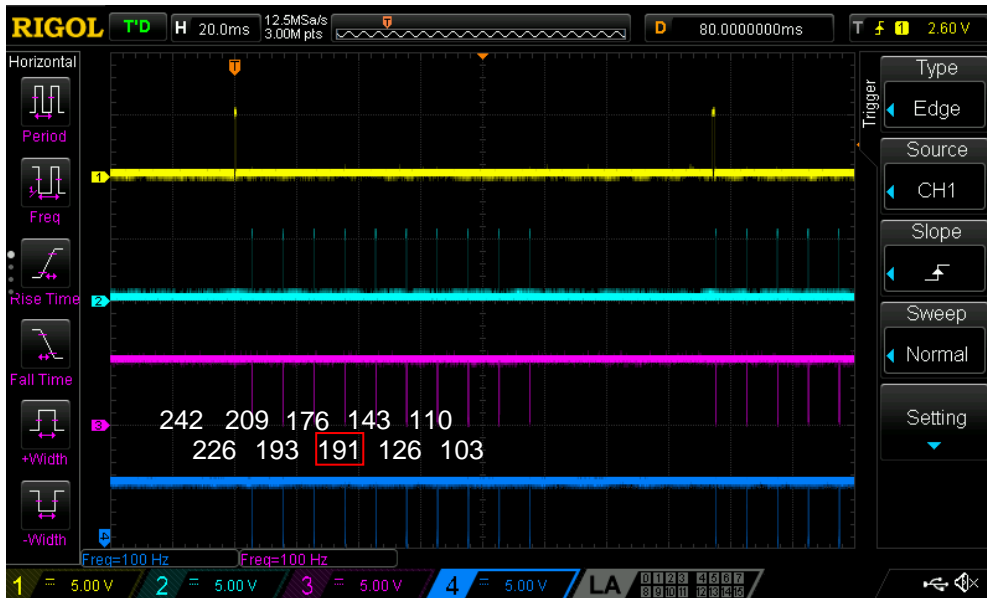
Figure 1: Example Data

The example data capture below shows ten periodic I<sup>2</sup>C reads of CNT2/DLY2 configured to count down at about 16 clocks per read. The sixth read sample erroneously shows a value greater than that of the fifth. The seventh sample reads as if the previous I<sup>2</sup>C error never occurred - the difference from the fifth sample (176) to the seventh (143) is 33 clocks or 16 clocks + 17 clocks as expected.

Channel 1 (yellow/1st line) – PIN2 (CNT2/DLY2 Out)

Channel 2 (light blue/2nd line) – PIN1 (I2C Read Triggers)

Channel 3 (magenta /3rd line) – PIN8 (I2C SCL)

Channel 3 (dark blue /4th line) – PIN9 (I2C SDA)

If the possibility of incorrect I<sup>2</sup>C data reads can’t be accommodated for by external software checks, one can guarantee proper operation by stopping the CNT/DLY block’s clock during I<sup>2</sup>C reads through one of the following methods: by disabling the oscillator block, by reconfiguring the CNT/DLY block’s clock source, or by gating an external clock using a LUT (Look Up Table) in the signal matrix. After disabling the CNT/DLY block’s clock, the count registers can be read without error. Please note that this workaround will add the I<sup>2</sup>C read and processing time to the counter’s overall clock period.

The best workaround depends on the resource constraints of the application. If the oscillator block doesn't clock other logic elements within the design, a matrix output can be used to manually power down the oscillators for the I<sup>2</sup>C read. When the CNT/DLY block's clock source is routed internally from the oscillator block, I<sup>2</sup>C commands can temporarily reconfigure the CNT/DLY block's clock source registers to select "Ext. CLK. (From Matrix)." This action will disable the clock by connecting it to the ground. If the CNT/DLY block is clocked from the signal matrix, the LUT can be used to gate the clock during the I<sup>2</sup>C read.

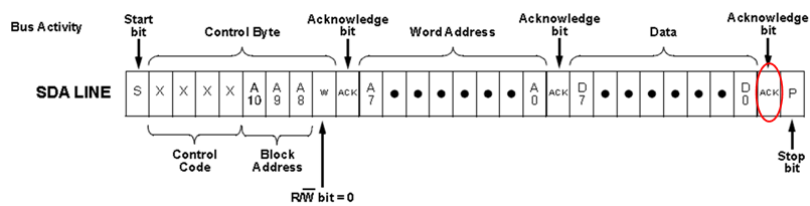
Figure 2: GreenPAK I<sup>2</sup>C Write Frame for Page Erase

To erase the NVM and the EEPROM, one must perform an I<sup>2</sup>C write to the "Page Erase Byte" located at 0xE3. The ACK bit which follows the "Data" portion of Figure 2 won't comply with standard I<sup>2</sup>C specifications. Please see the ACK bit circled in RED below.

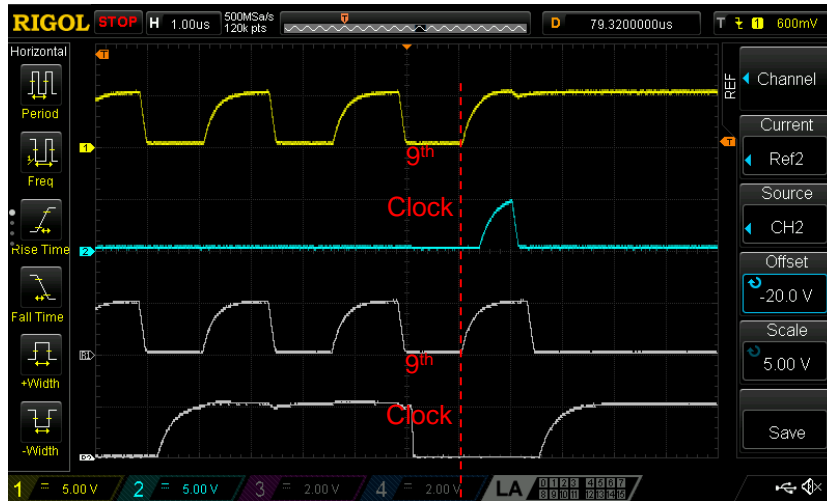
Figure 3: Non-I<sup>2</sup>C Compliant Behavior Oscillogram

The following waveform compares the regular I<sup>2</sup>C ACK behavior (Ref 1 - SCL and Ref 2 - SDA) with the non-compliant ACK behavior (Channel 1 - SCL and Channel 2 - SDA) generated by an I<sup>2</sup>C write to the "Page Erase Byte." During the 9<sup>th</sup> clock cycle, the SLG46827-A does not adhere to the "data hold time" specification by releasing SDA (Channel 2) before the falling edge of the clock pulse on SCL (Channel 1).

Channel 1 (yellow/1<sup>st</sup> line) – SCL ~ Non-I<sup>2</sup>C Compliant ACK Behavior (After Data byte)

Channel 2 (light blue/2<sup>nd</sup> line) – SDA ~ Non-I<sup>2</sup>C Compliant ACK Behavior (After Data byte)

Ref 1 (grey/3<sup>rd</sup> line) – SCL ~ Regular I<sup>2</sup>C ACK behavior (Before Data byte) – (5 V/div)

Ref 2 (grey/4<sup>th</sup> line) – SDA ~ Regular I<sup>2</sup>C ACK behavior (Before Data byte) – (5 V/div)

On a system level, other I<sup>2</sup>C devices might interpret this non-compliant ACK as an additional STOP and START condition. By definition, a START condition occurs when SCL is HIGH and SDA transitions from HIGH to LOW. A STOP condition occurs when SCL is HIGH and SDA goes from LOW to HIGH. After the 9<sup>th</sup> clock cycle, the MCU should generate the final STOP condition to indicate the end of the transmission to all I<sup>2</sup>C slaves on the bus.

No workaround is required for the GreenPAK device as the NVM and EEPROM erase operations will execute properly. For verification, one can perform an I<sup>2</sup>C read of the erased pages. Excluding protected pages, all erased NVM and EEPROM registers should be cleared.

Adjust the MCU’s I<sup>2</sup>C firmware to catch and ignore a “NACK” from the GreenPAK device when the “Page Erase Byte” is addressed. In light of the additional STOP and START conditions, the behavior of other I<sup>2</sup>C slaves on the same bus should be evaluated.

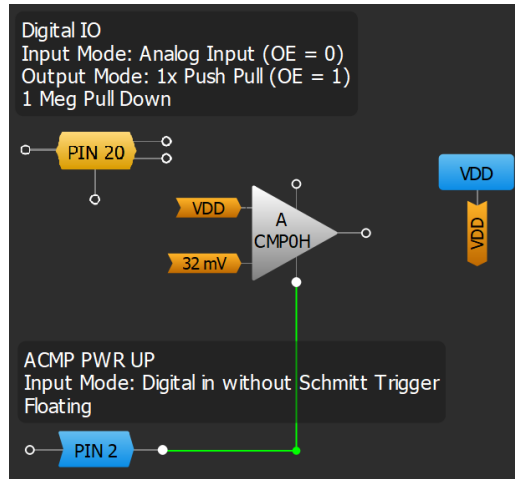
Figure 4: GreenPAK Input Structure Test Schematic

Figure 4 shows the GreenPAK configured with IO14 as a Digital IO with a 1 MΩ pull-down resistor. Since the OE pin is connected to 0 V, this pin is acting as an “Analog IO.” As seen in Table 1, IO14 and V<sub>DD</sub> are both input options for ACMP0H. In this example, IO0 is being used as a digital input to enable and disable the ACMP.

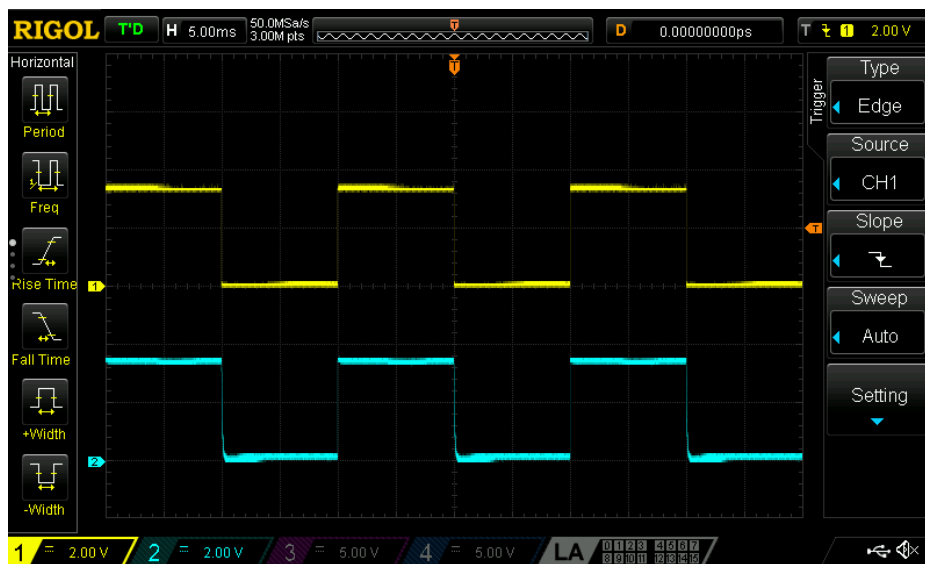
Figure 5: ACMP Input Structure Behavior

Figure 5 shows that IO14 in analog input mode is pulled HIGH by the V<sub>DD</sub> signal whenever the ACMP is enabled despite having an internal pull-down resistor. This behavior is caused by an internal connection between V<sub>DD</sub> and IO14. Similar behavior can be reproduced when one ACMP’s IN+ port is connected to another ACMP’s IN+ port.

CH1 (Yellow): ACMP PWR UP (IO0)

CH3 (Light Blue): Digital IO w/ Analog Input Mode Configuration (IO14)

There is no workaround for this behavior. With this in mind, the IOs should not be used as digital IOs (with “Input mode” set to Analog input) or as digital outputs (with “Output mode” set to 1/2/4x 3-State Output) if the respective ACMP is enabled and connected to another input source.

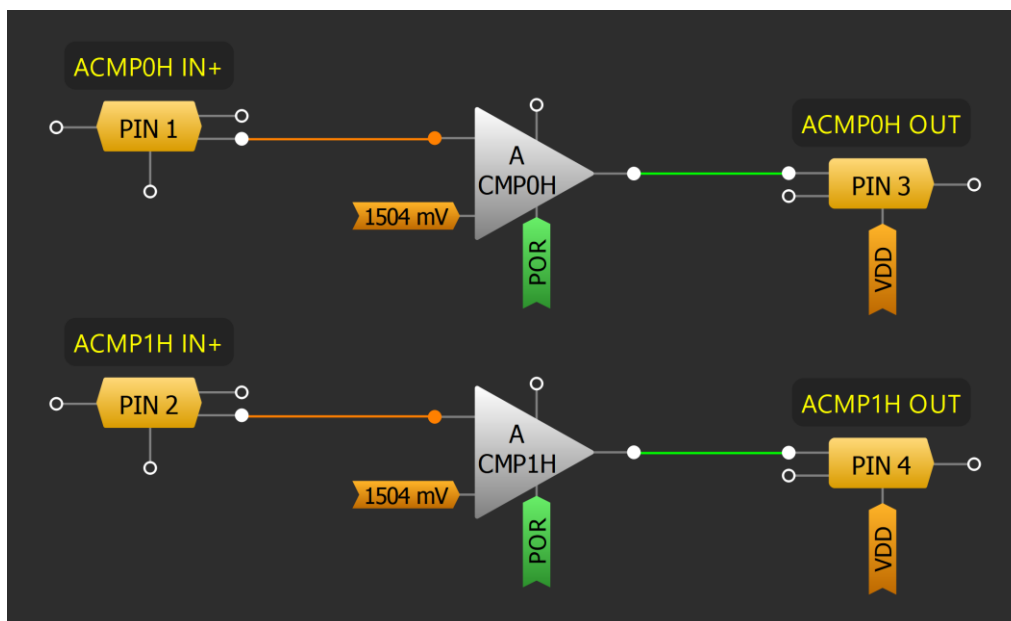
Figure 6: Testing Design

If using ACMPxH with 32 mV hysteresis, ACMPxH output could be glitching when ACMPxH positive input (IN+) is close to the negative input (IN-). It can happen when  $V_{DD} = 4.0\text{ V}$  or higher and  $V_{ref}$  ranges from 0.832 V to 1.024 V, and 1.312 V to 1.44 V.

- Use the deglitch filter connected to the ACMPxH output.
- Avoid conditions described in paragraph 3.4.2.

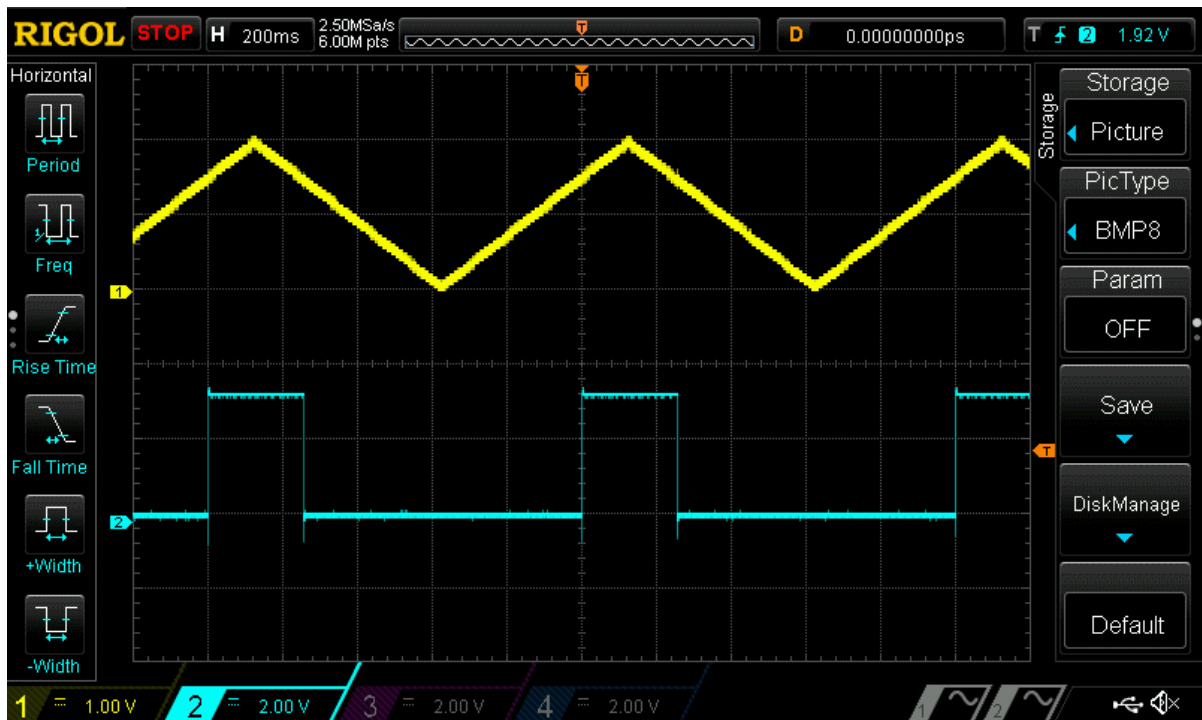
Figure 7: ACMP Output during Glitching

Channel (yellow/top line) - PIN#1 (ACMP0H IN+)

Channel (light blue/top line) - PIN#3 (ACMP0H OUT)

1. Waveform at  $V_{ref} = 1504\text{ mV}$ , hysteresis is equal to 32 mV.

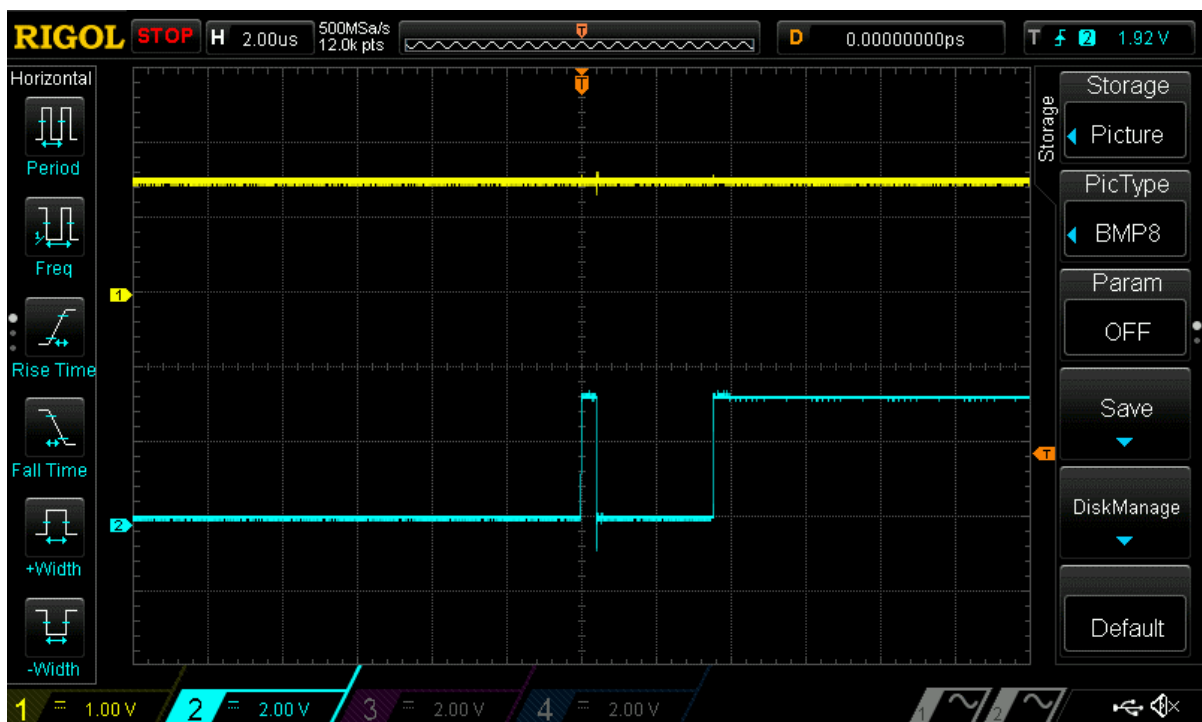
Figure 8: Zoomed ACMP Output during Glitching

2. Waveform at  $V_{ref} = 1504 \text{ mV}$ , hysteresis is equal to  $32 \text{ mV}$  (zoomed rising edge).

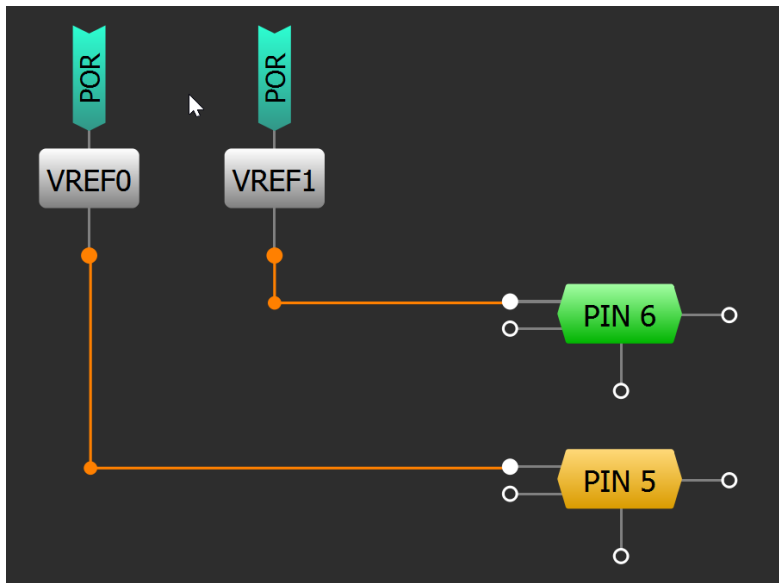
Figure 9: Testing Design

If using Vref output in the range of 32 mV to 192 mV connected to the analog input/output PIN, the Vref accuracy is very low due to the built-in buffer's offset.

There is no workaround.
